# Variable Voltage Substation Electrical Fire

## *Environmental Radiological Assistance Directory*

John Seabury, PE, CIH

SLAC Accelerator Directorate Quality and Safety Manager

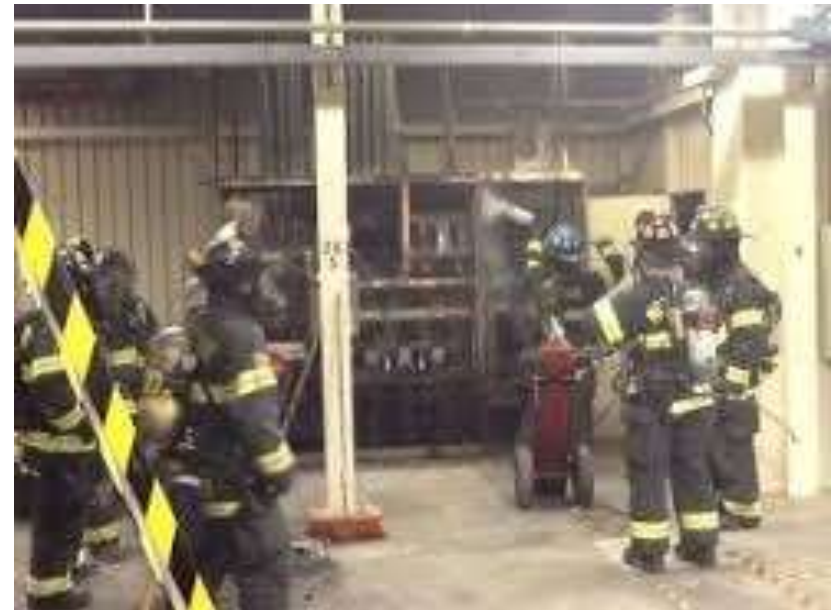
- 6/25 Wednesday – LCLS and FACET delivering beam to users
  - 2145 Accelerator Main Control Center noted VVS13 tripped. Vesda system alarmed. Onsite electrician reported that VVS13 was on fire.
    - Second alarm, 22 apparatus from sheriff and local fire departments responded
    - So did news crews from three local television stations
  - 2225 12kV locked off, suppression commences. EOC activated, notifications made.
  - 2300 fire is out
  - 2345 PPS is interrupted, locked out Linac East (Sectors 0-20)
- 6/26 Thursday
  - ~0200 EOC deactivated
  - News report went viral
  - During day: assess damage to 12kV

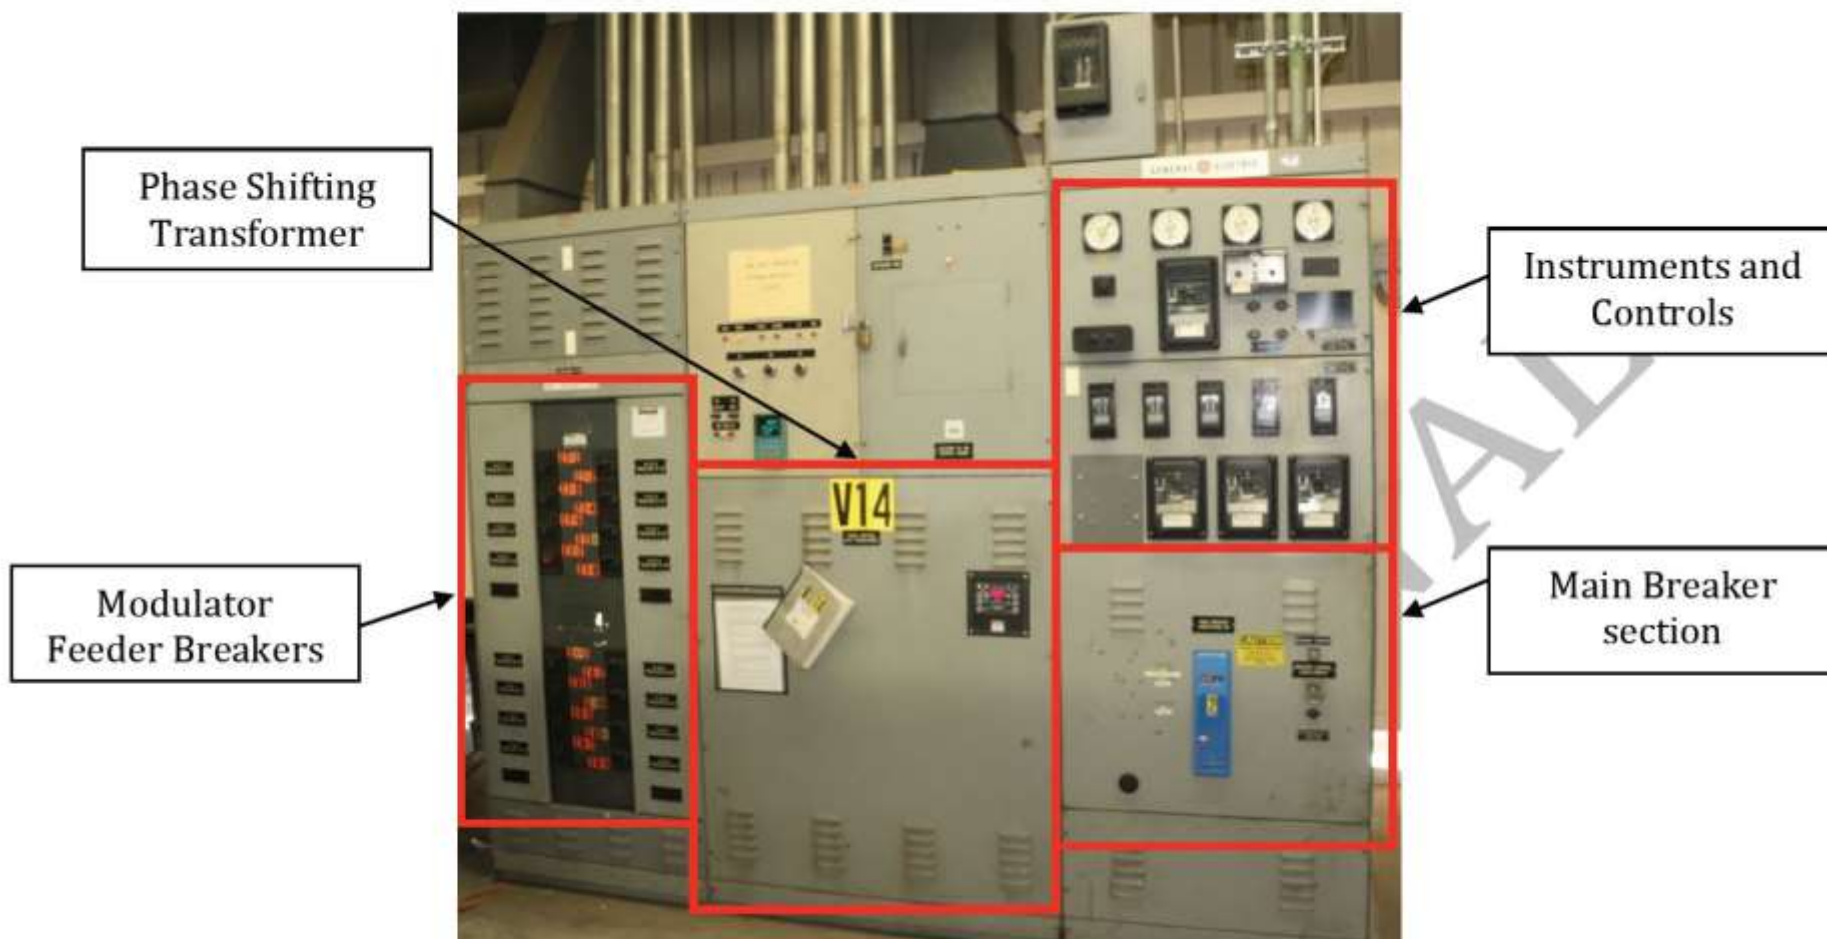
Figure 1. Photo of the secondary switchgear cabinet of a typical VVS.

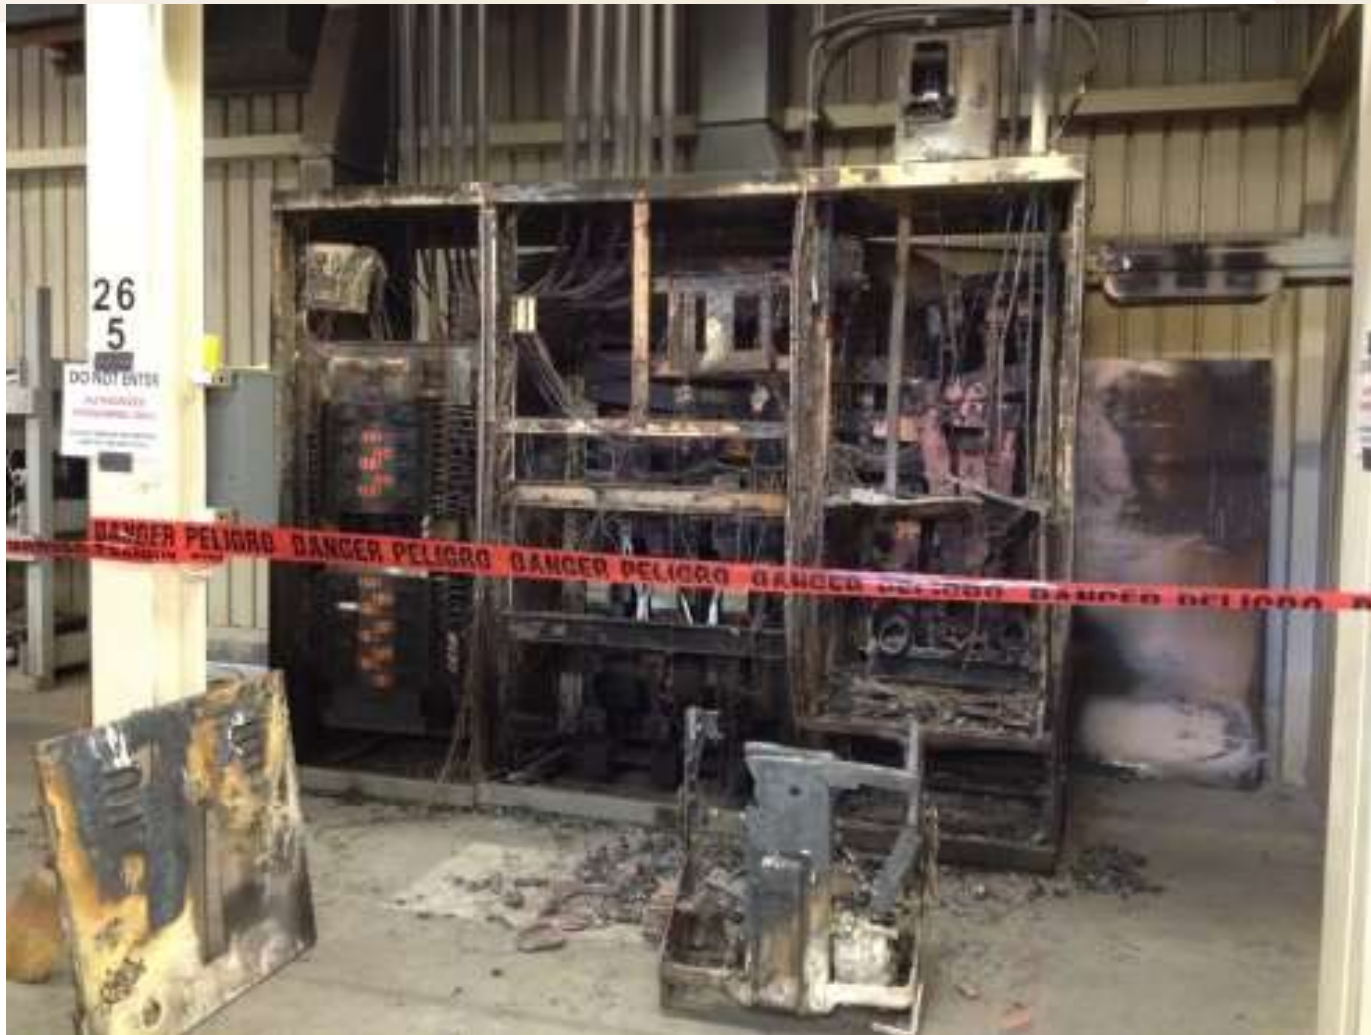
# VVS13 After the Fire

- Fire started as a result of an arc flash and ongoing electrical faulting between the input connectors of the secondary main breaker
- Unclear what started the arc flash. May have been high resistance, may have been contact with a displaced object within the cabinet. Downstream breaker may have contributed.
- Root Causes
  - Poor maintenance condition of VVS 13
  - Lack of effective stewardship of the VVS system by Facilities Department
- Contributing Causes
  - Fault protection systems inadequate
  - Lack of routine maintenance
  - Lack of condition assessment
  - Changes in operations increased frequency of breaker switching

- Initiate an effective equipment stewardship program for critical infrastructure systems
- Define and evaluate critical electrical equipment for compensatory measures that could be implemented until full correction
- Evaluate all electrical and fire protective devices for adequacy to protect SLAC against risk and recommend upgrades
- Review circuit breaker use patterns to identify those with increased risk of failure
- Resolve all issues in a timely manner

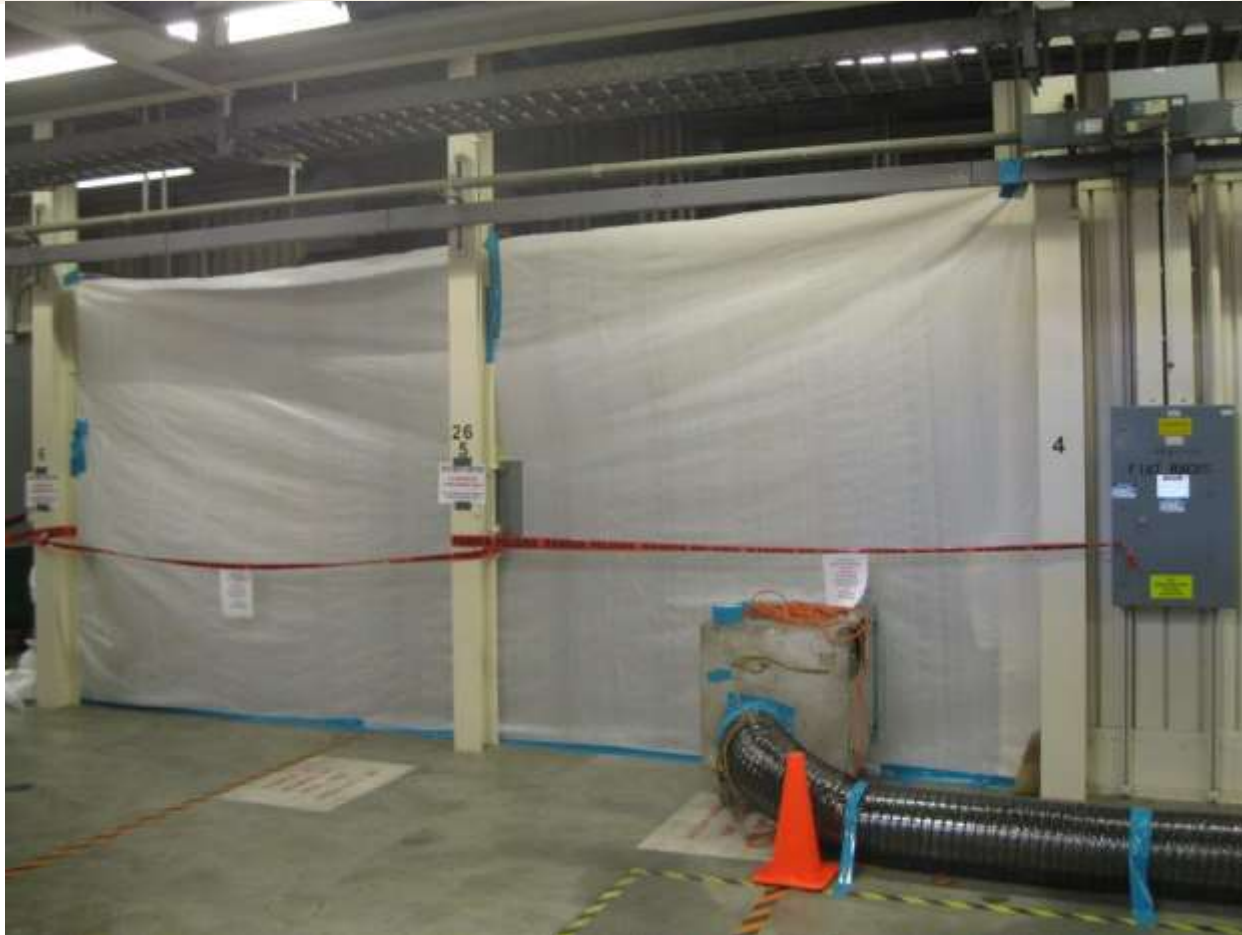
...containment

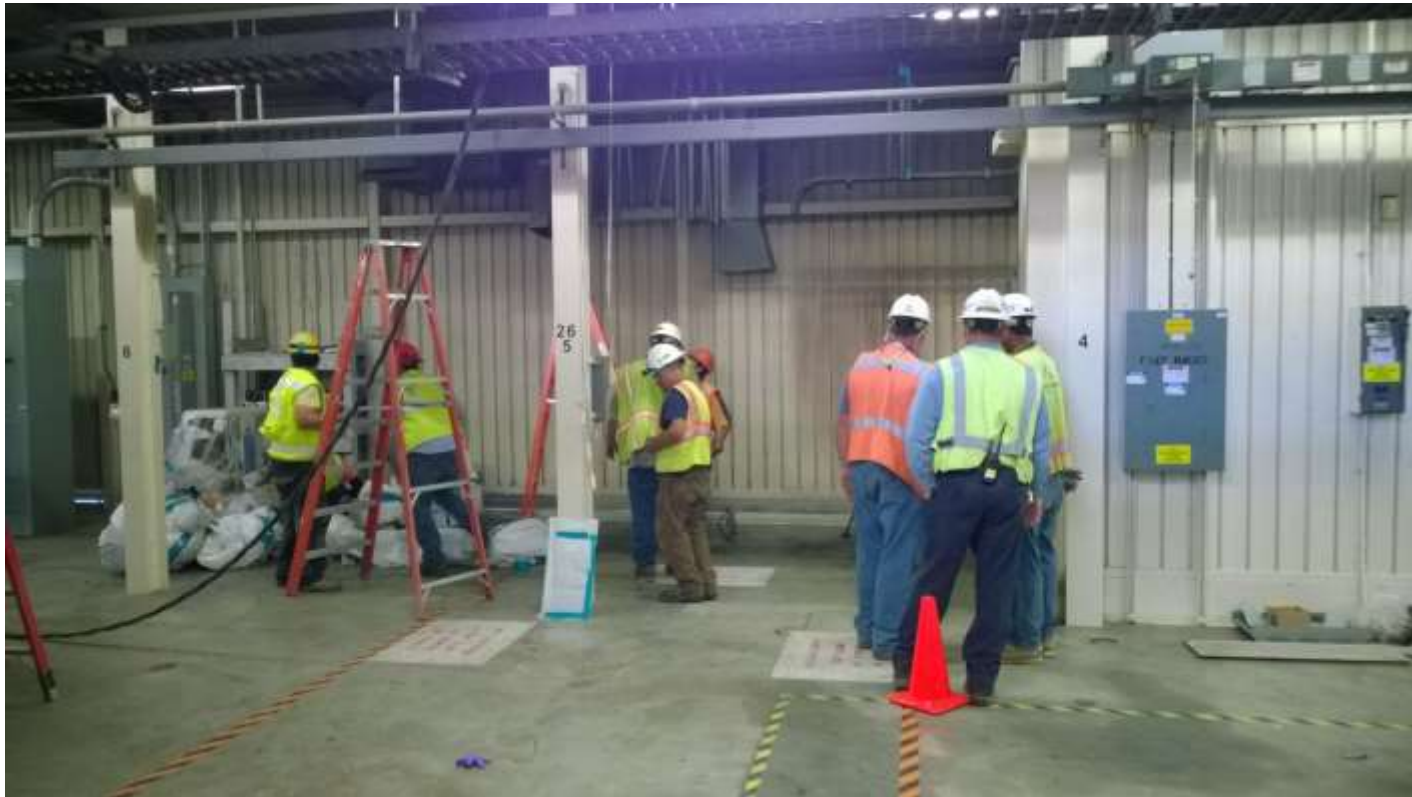
...abatement complete, clearance received,  
containment removed, VVS removed.

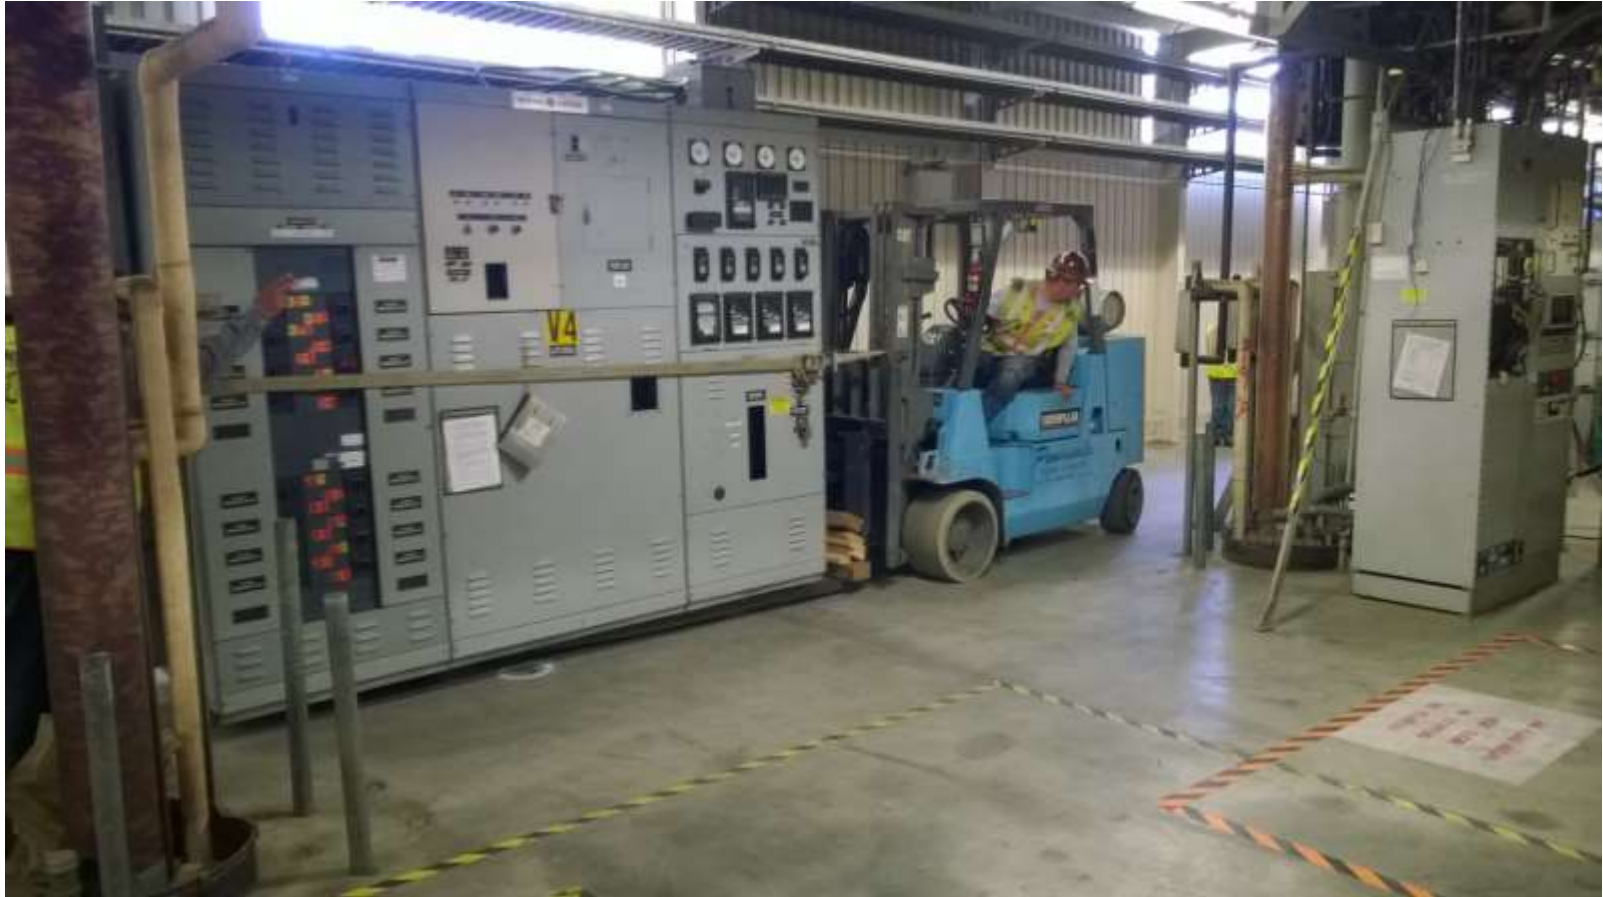
...VVS4 riding down the gallery

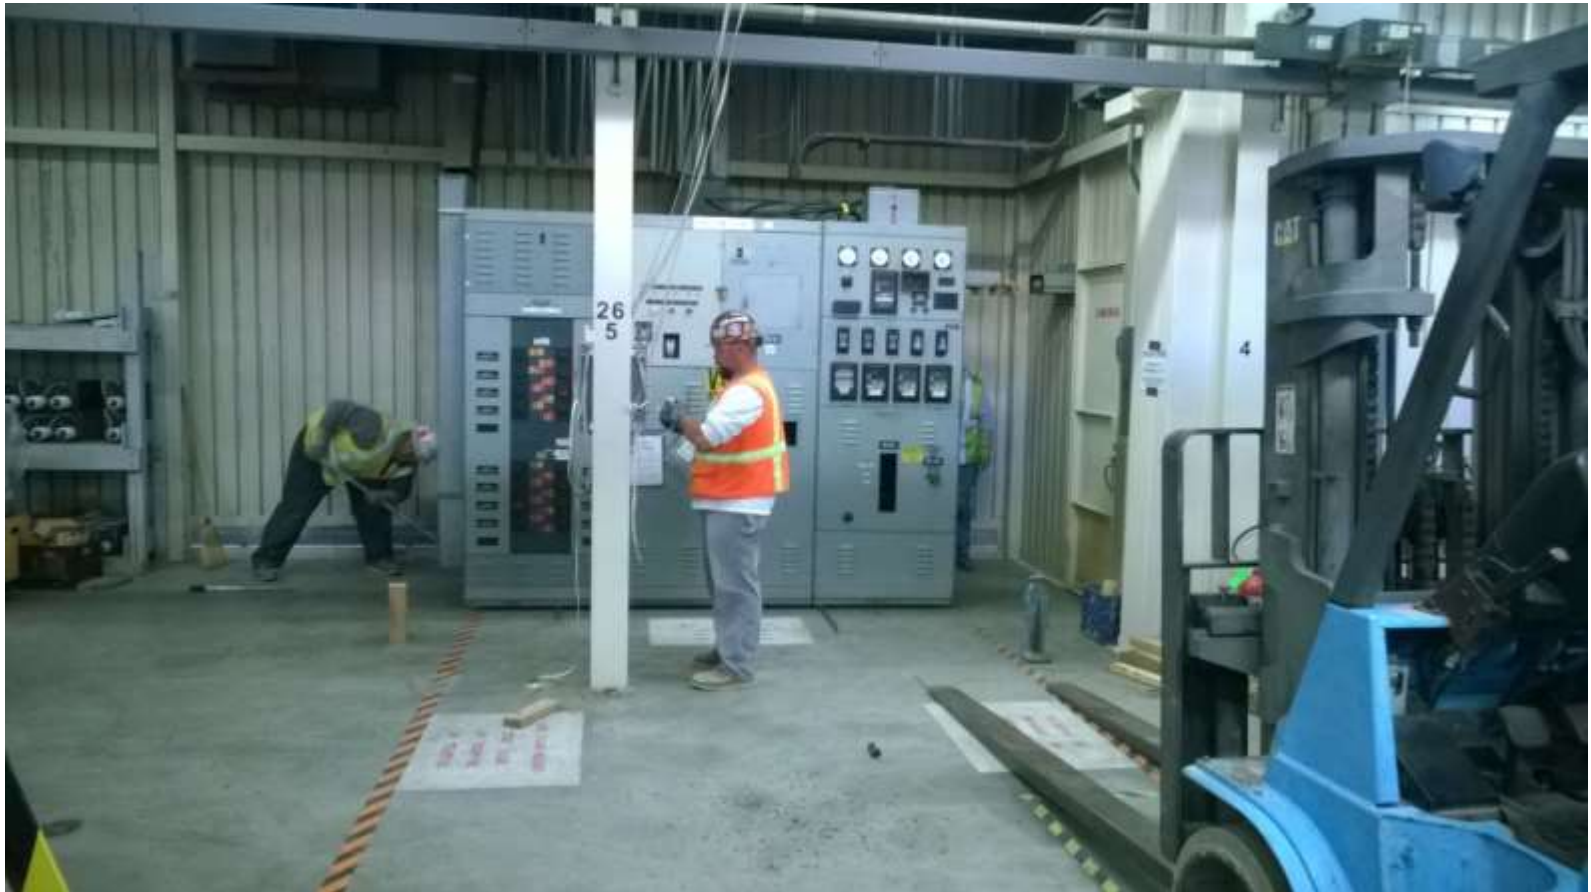
...VVS4 at its new home in S26

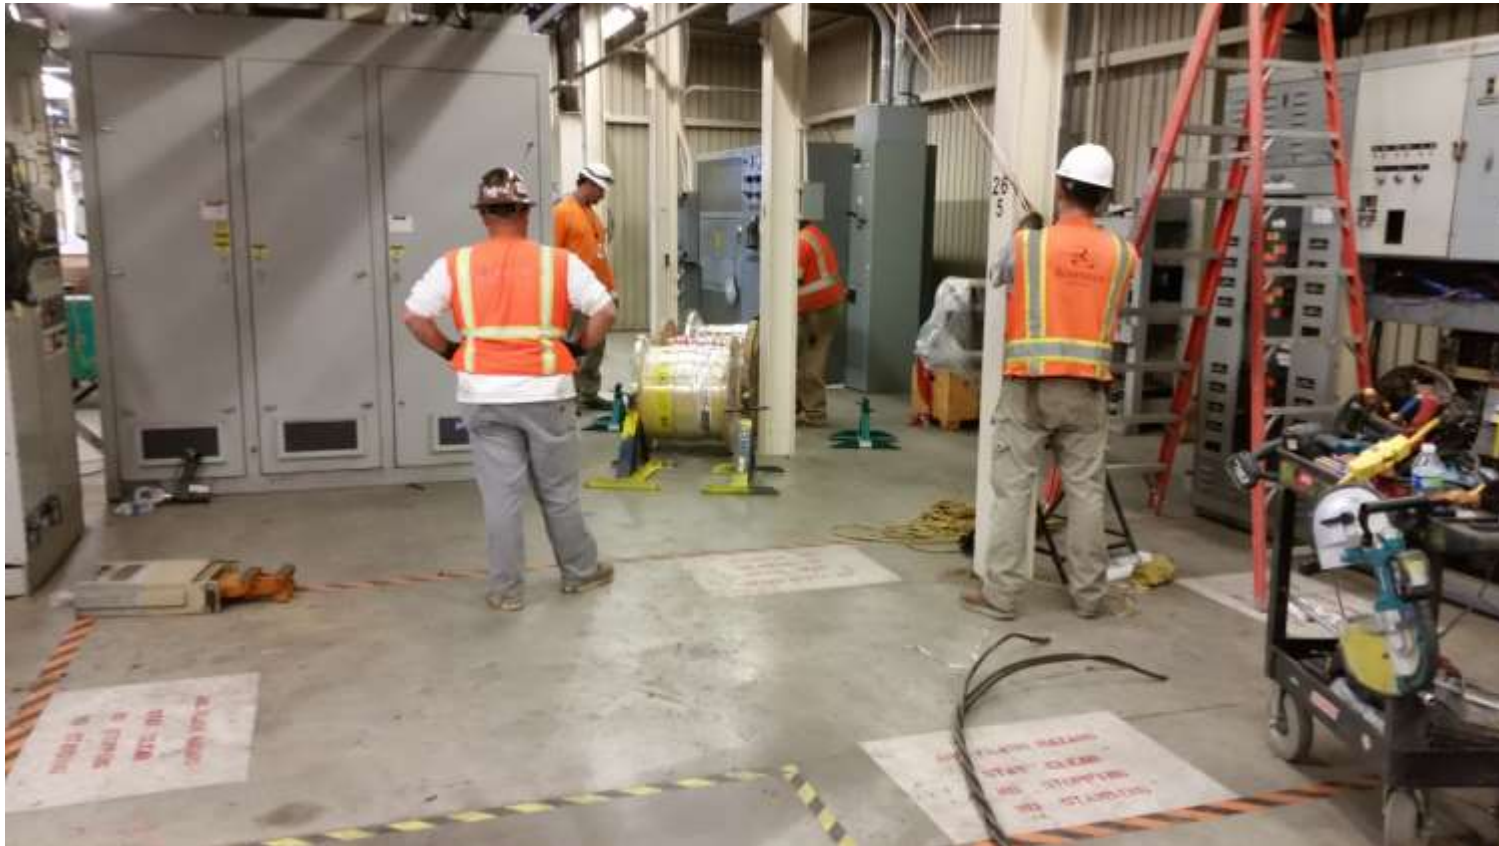
...new modulator conductors readied for pull

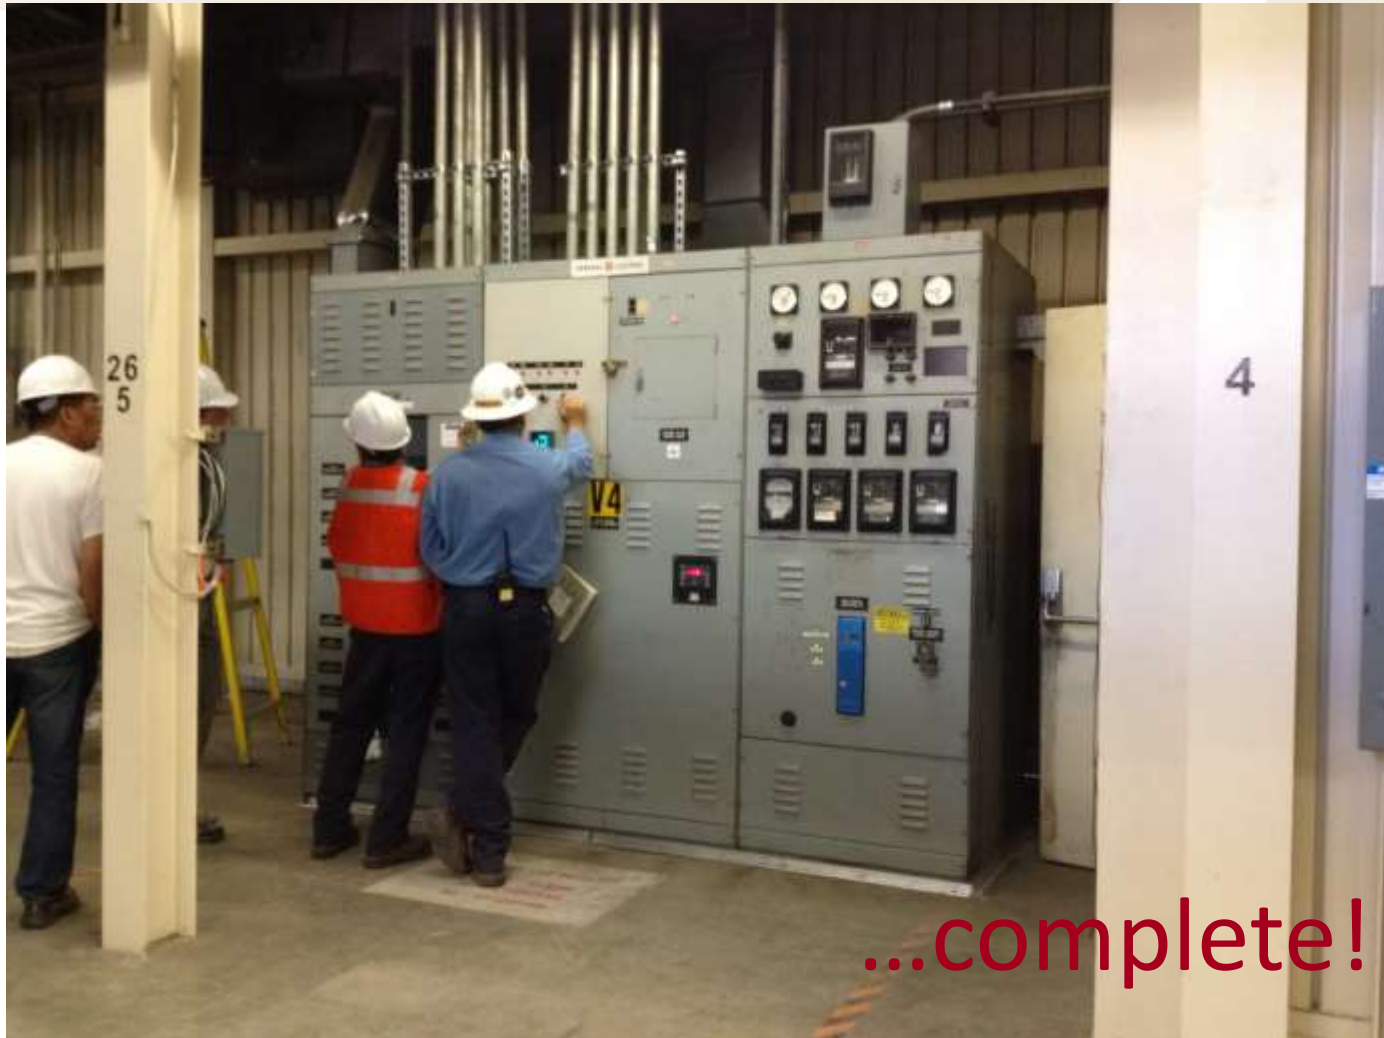
...complete!!!
